IIR WG Refrigeration Safety

Alexander Cohr Pachai, Jeannett Normann
Johnson Controls Denmark
Communicating author e-mail: alexander.c.pachai@jci.com

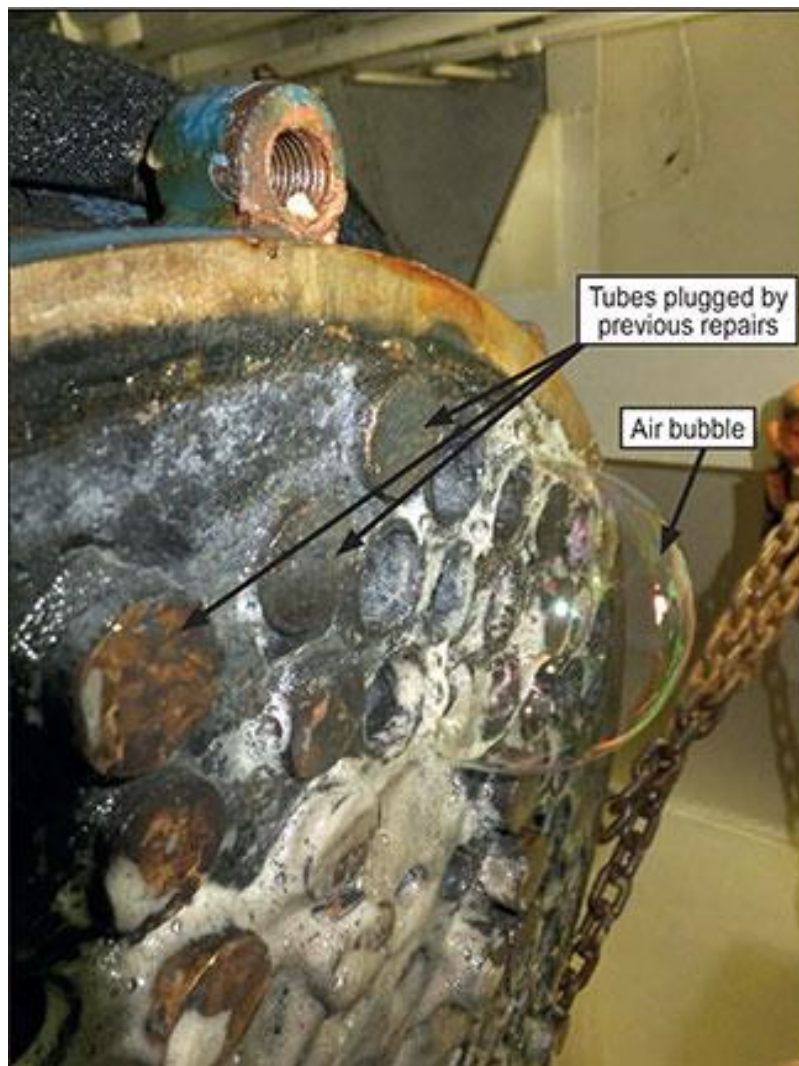
In October 2018, the net media Cooling Post (2018) reported about a crew member on a trawler that had been asphyxiated by an R-22 leak. The leak occurred in the evaporator and was not the first leak on that evaporator, which had been repaired before. The picture from the report looks very similar to the picture of the evaporator

in the accident from an ice rink in Canada (Ferne Memorial Arena ice rink, also mentioned in this paper). The R-22 had travelled with the refrigerated seawater into the tanks. When three other crew members climbed down to their colleague, they quickly became dizzy and felt uncomfortable, so they abandoned the task and climbed back up. The O₂ level was measured to 6%, which is dangerously low.

Figure 1: Some of the tubes had previously been leaking and blocked.

The lesson learned from this accident is that all cargo holds should be equipped with detectors to measure both the refrigerant concentration and the oxygen level, because the oxygen can be depleted by other gases as well. You may also argue that the tanks should be ventilated when crew members enter them to avoid similar situations.

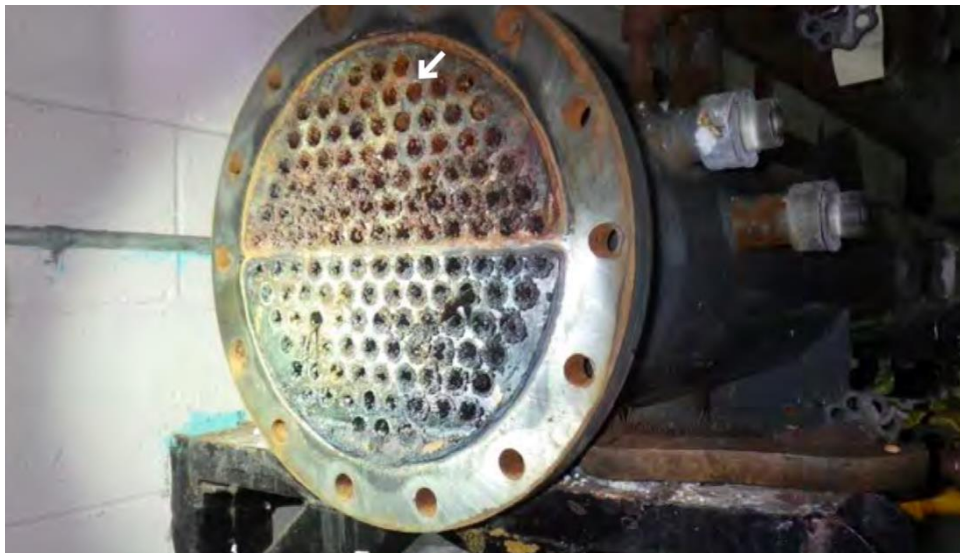
The problems started with a relatively small leak, but the leak was not dealt with over the years, and, in the end, the secondary brine loop gave in for the pressure, and the accident happened.

Figure 2: The heat exchanger had previously been reported to be leaking, and some of the tubes were blocked.
